Van Ness Corner Bulb Design Evaluation Report

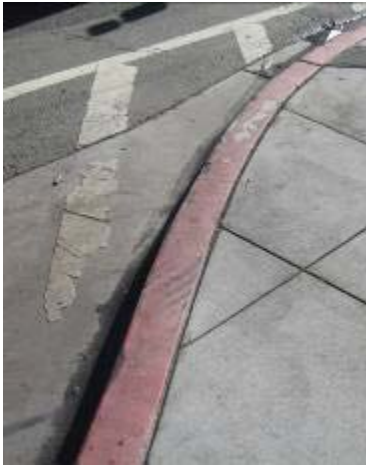
<p>Markings barely visible, low instance of markings [shown: Ellis]</p>

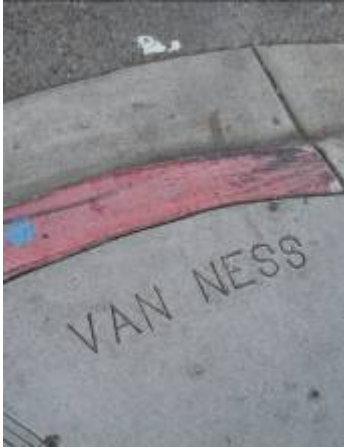
<p>Markings visible, located in more areas around curb [shown: Golden Gate]</p>

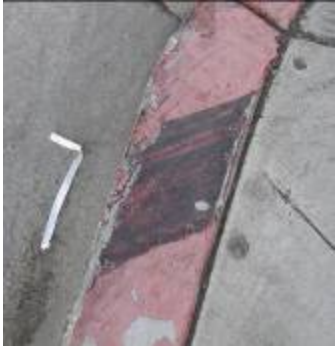
<p>Markings visible and dark, located in more areas around curb [shown: Turk]</p>
Structural Damage

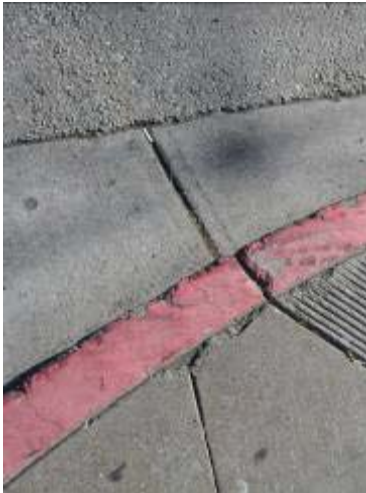
<p>Curb edge show signs of wear, minor slab crumbling [shown: California]</p>

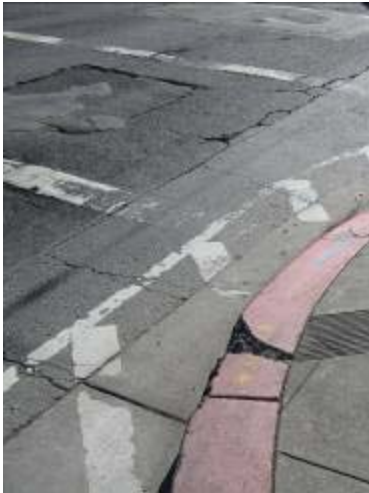
<p>Curb slab intact but more significant crumbling [shown: Hayes]</p>

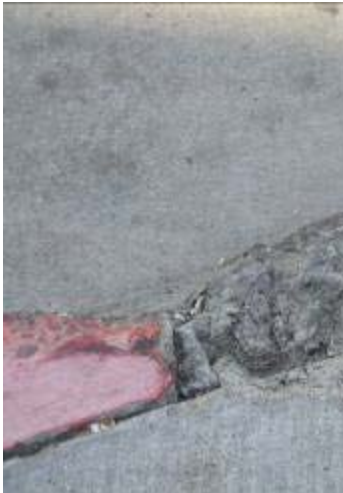
<p>Part of curb slab missing, dented, worn away [shown: California]</p>

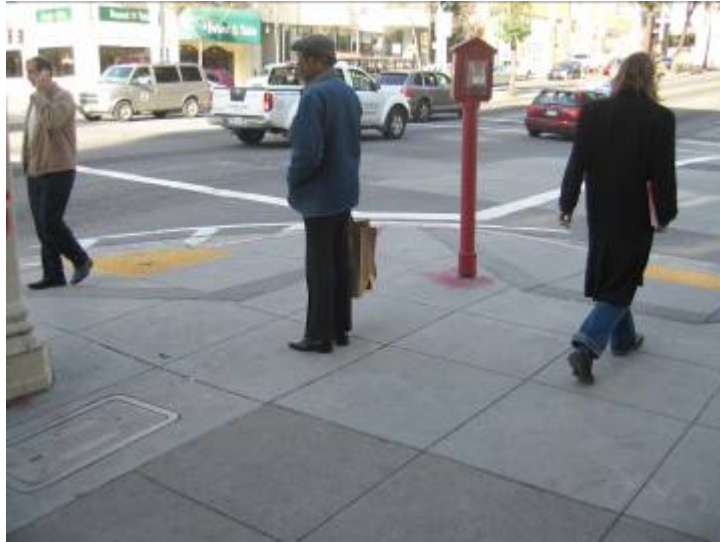
Figure 5. Eddy and Van Ness: Space to Wait

The bulbs were observed to improve pedestrian walking and crossing conditions in addition to slowing down turning vehicles. First, they provided pedestrians with space to wait while crossing the street without impeding through-pedestrian traffic moving along the sidewalk. See Figures 5 and 6 for examples of pedestrian curb bulb use. Pedestrians also stepped onto the bulbs to watch for traffic, increasing their visibility to drivers and vice versa.
