Memorandum

SUBJECT: 2/25/20 Board Meeting: Independent Management and Oversight Report on the San Francisco Municipal Transportation Agency's Siemens Light Rail Vehicle Procurement

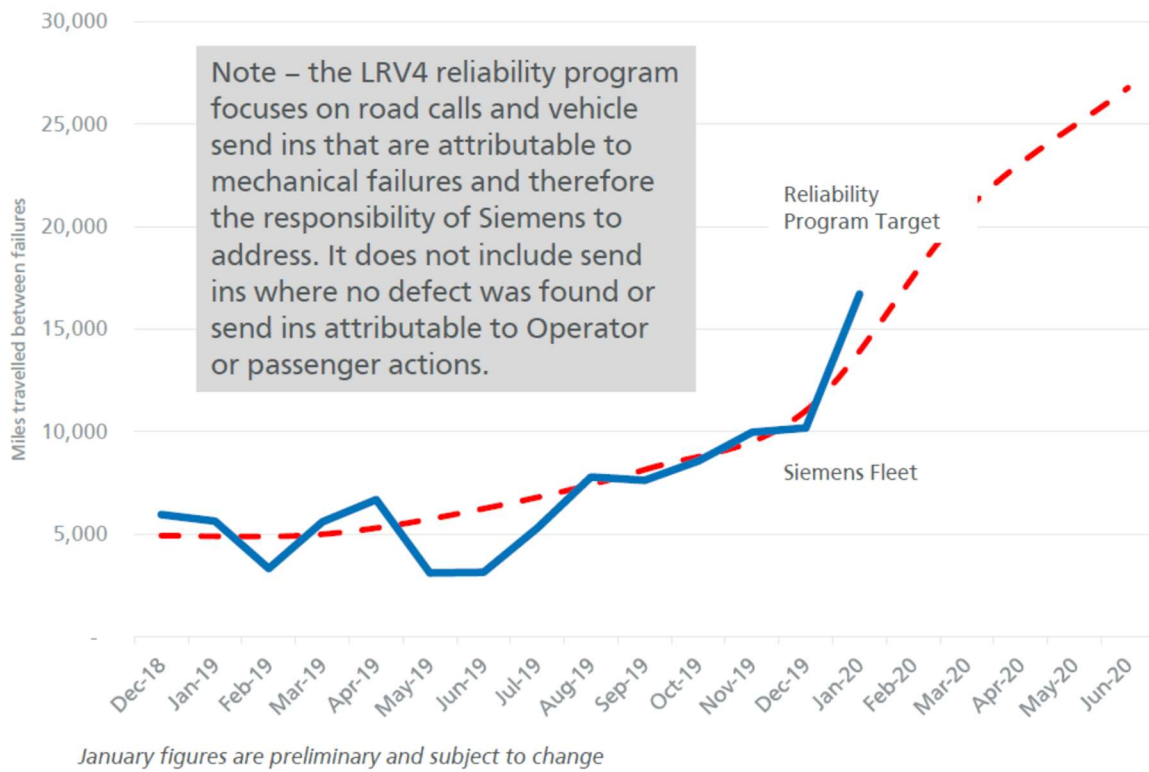
Exhibit 22 - LRV4 Projected MDBTF

The MDBF trend for the LRV4s is calculated on a monthly basis by Siemens and reviewed by SFMTA staff and their Failure Management Board. This information is reviewed to identify trends and any particular causes for changes. For example, the MDBF was positive at the end of 2018, but in February of 2019 then took a negative hit for the APS faults. It was the rainy season and a number of APS units failed from excess water in the APS Line Choke Compartment. This also impacted availability and mileage as all car APS units needed to be modified with the temporary solution. Once corrected the trend was again positive. In May the MDBF took another negative hit for both the couplers and the doors. And even though there was only one recorded failure for each, the repairs were required on all cars, which impacted availability and mileage. The continued flat spotting of the wheels is not considered a failure, but it does impact MDBF in that it impacts the availability and mileage put on the LRV4 cars.

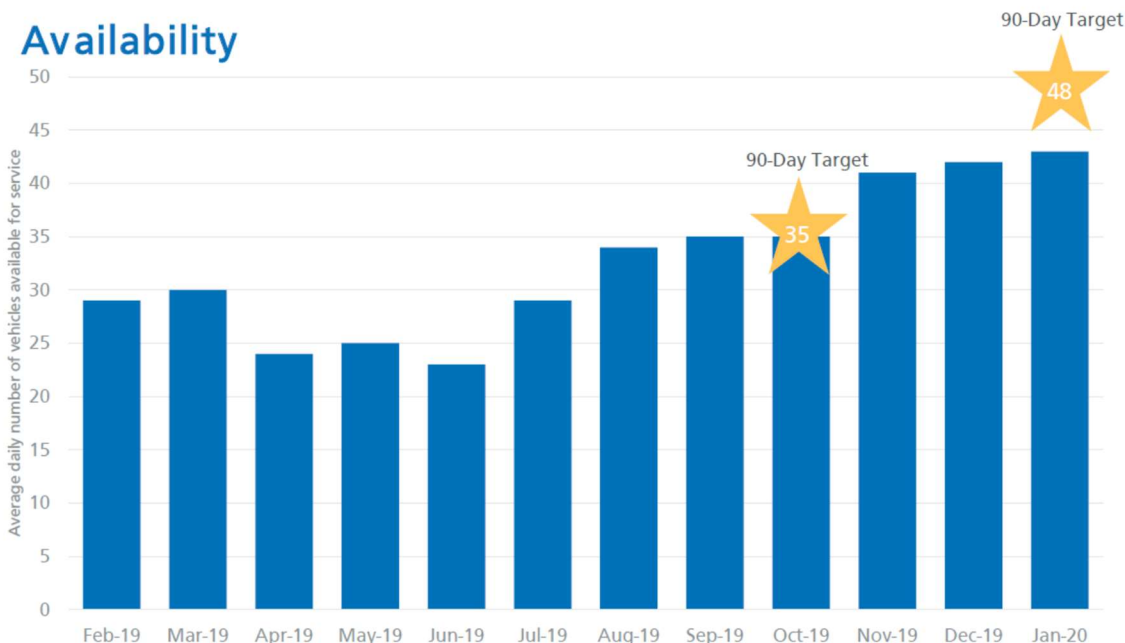
Exhibit 23 – LRV4 Daily Availability

The MDBF improvement also contributes to the increased availability of LRV4s for revenue service. Exhibit 23 shows the daily availability of LRV4s over time. This accounts for delivery of vehicles and availability due to planned and unplanned maintenance activities.
