# Memorandum

**DATE:** February 21, 2020  
**TO:** Transportation Authority Board  
**FROM:** Eric Cordoba- Deputy Director for Capital Projects  
**SUBJECT:** 2/25/20 Board Meeting: Independent Management and Oversight Report on the San Francisco Municipal Transportation Agency’s Siemens Light Rail Vehicle Procurement

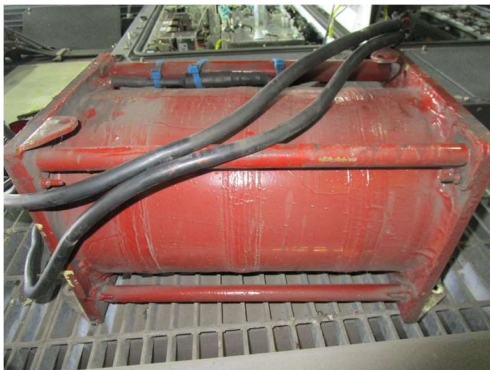
The root cause was determined to be the mounting of the APS unit. The APS unit brackets placed the bottom of the APS unit at approximately the same plane as the bottom of the compartment [*Exhibit 2*]. Therefore, water would accumulate in the compartment and not be able to get under/past the APS unit to the drain, splash into the APS and arcing would occur. The water volume, although minimal, was enough that during car movements the water would splash into the APS unit and the APS unit would fail. Note that the APS unit requires air circulation for cooling and is therefore not sealed from water.

*Exhibit 2 - Old Design – Brackets at same plane as bottom of APS*

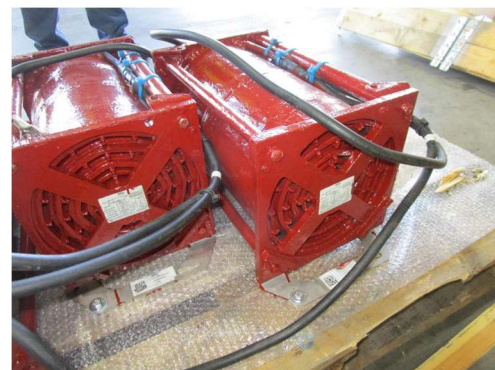
*Exhibit 3 – New Design – Brackets extend below bottom of APS for drainage clearance*

In order to provide clearance for water to be drained underneath the APS, the mounting ears that were integral to the APS frame were removed and new brackets were designed and attached to the APS frame that slightly raised the APS off the floor of the APS line choke compartment [*Exhibits 3 and 4*]. The compartment provides for the additional APS height and the cover and car clearance are not impacted.

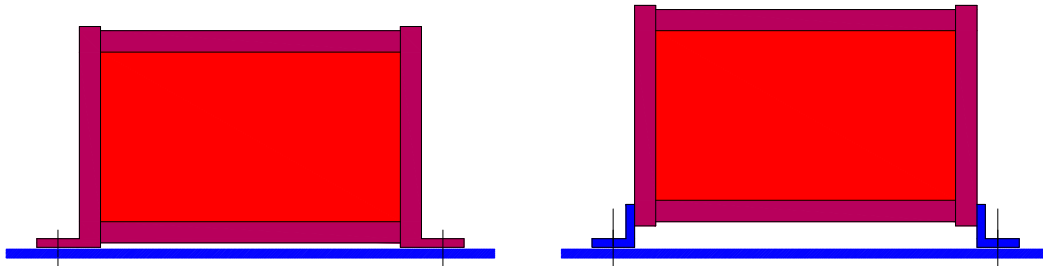
*Exhibit 4 – Old design on the left with ears integral to the frame. New design with mounting brackets separate from the frame raising the APS unit above the compartment floor for drainage clearance*

Once the root cause had been identified, washers were placed between the APS mounting frame ears and the compartment floors as a temporary fix to provide clearance for drainage on 100% of the cars. The permanent solution, which has been installed on all phase 1 LRV4s, is the new raised mounting brackets.

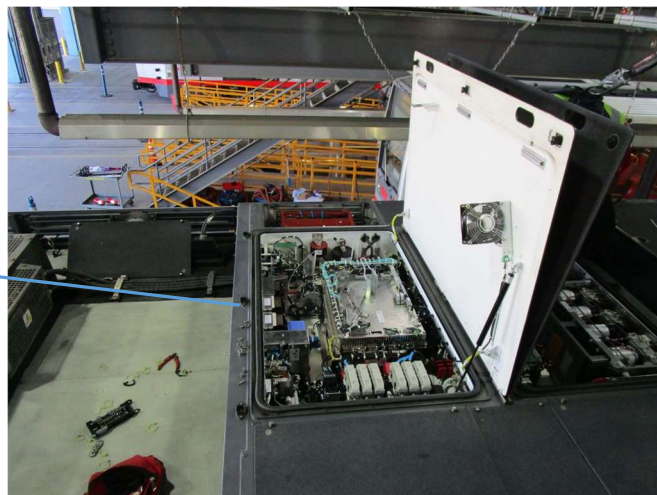
*Exhibit 5 – Installation of new APS unit in process*

New APS units with brackets were provided and installed by Siemens under warranty at no cost to SFMTA. Exhibit 5 shows Siemens installing a new APS unit on one of the LRV4s.

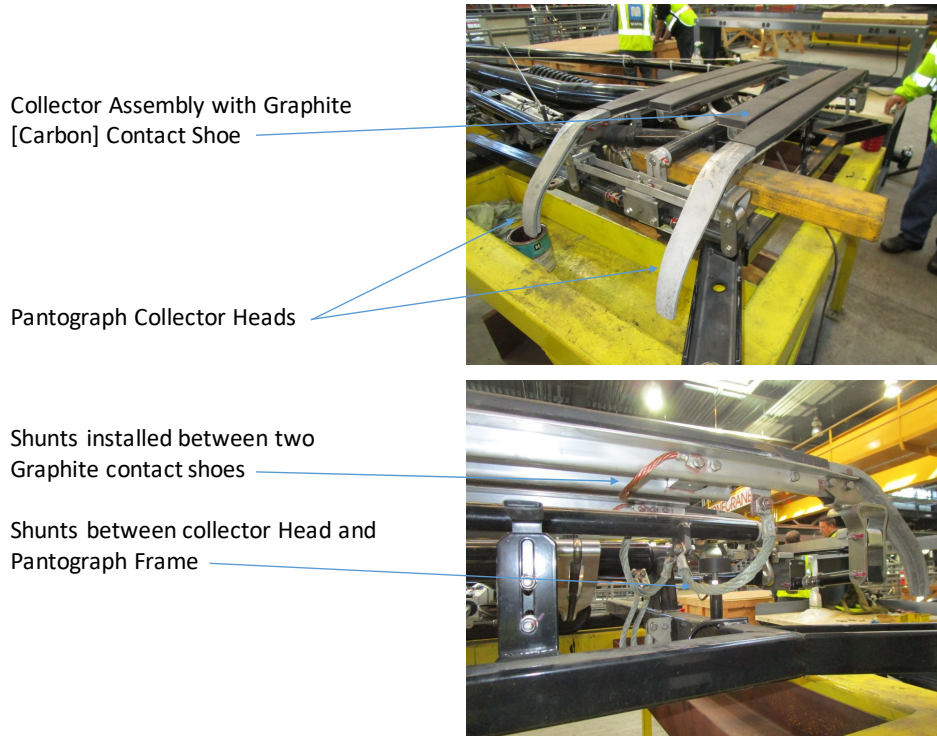
*Exhibit 8 – Collector Assembly with Shunts and Nordlock Washers installed*

Although there was only one such failure in the system, because of the severity of the failure and the potential to damage not only a car but also the catenary, all Nylock nuts on the pantographs were replaced with metal Nordlock washers and standard nuts. Also, eight (8) shunts were installed on each pair of collector heads to direct the path of the current from the graphite collectors and blocks through the shunts to the pantograph arms, thereby moving the current around the mounting hardware.

The solution has been tested and approved by the Safety and Security Subcommittee including CPUC. All pantographs have since been modified, as a Siemens warranty repair, and the issue is closed.

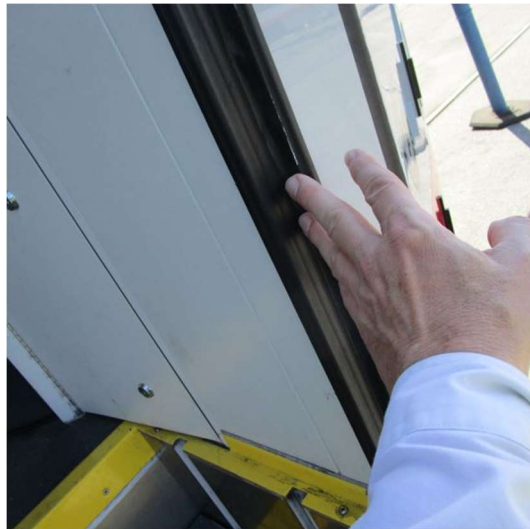
The door design with only one sensitive edge strip left a gap at the interlock point when the door closes where an object or hand could be pinched. [*Exhibits 9 & 11*].

*Exhibit 9 – Fingers shown on door pinch point*

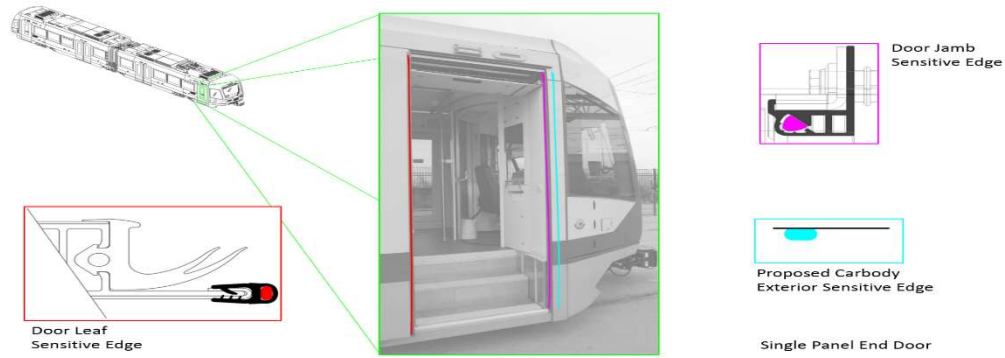
*Exhibit 10 – Detail of Sensitive Edge Modification*

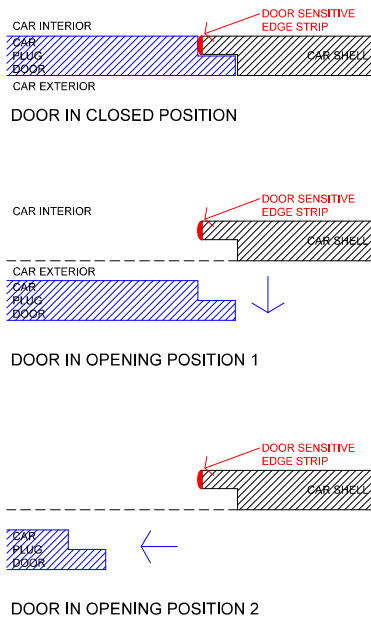
*Exhibit 11 – Sketch of Original Door Design*

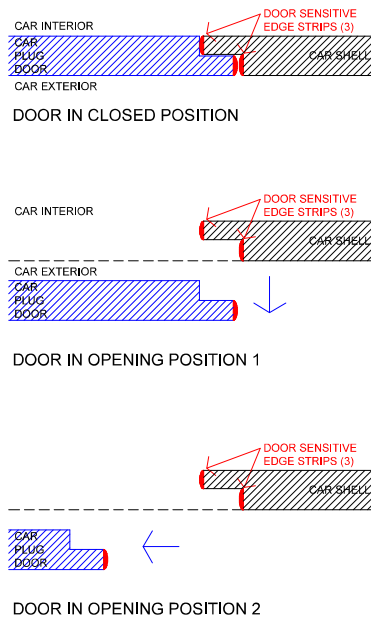
*Exhibit 12 – Sketch of Modified Door Design*

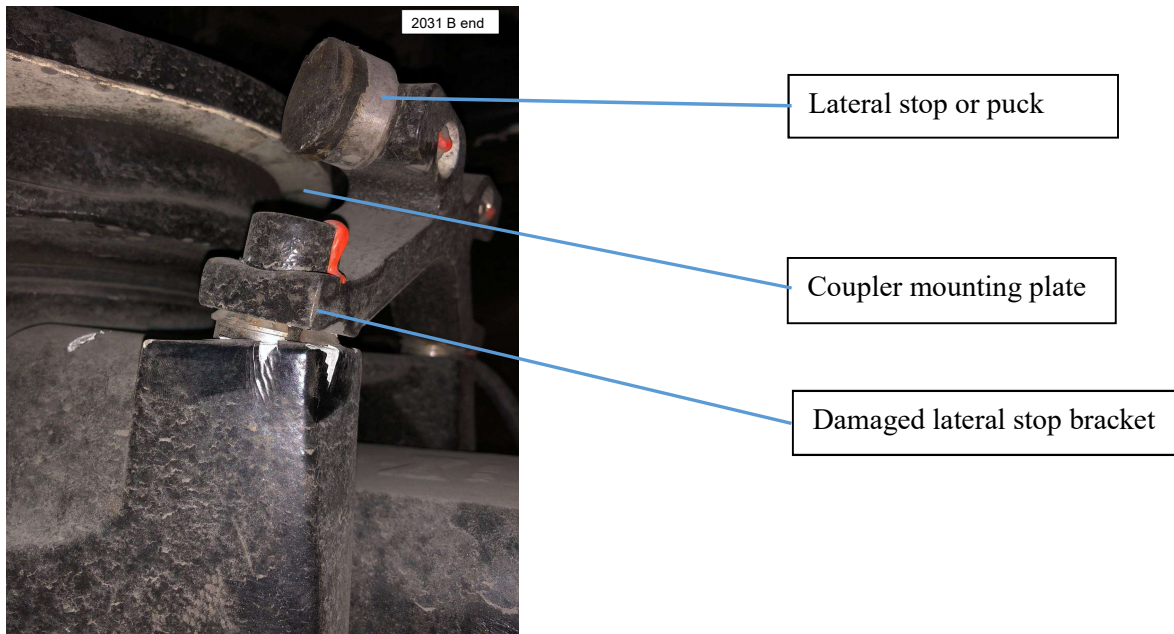
The only unusual variable that appeared in the inspections is that the lateral stop bracket, which limits the coupler horizontal swing during maintenance had been damaged and partially detached [Exh. 14]

*Exhibit 14 – Lateral Stop and Upper Clam Shell Damage*

Exhibit 14 also shows that the rubber piece on the stop, which is called a puck, is larger than the lateral stop bracket and is at the height of the coupler mounting plate. Note also that the coupler mounting plate, which is part of the car not the coupler, extends beyond the coupler assembly, which mounts to the plate.

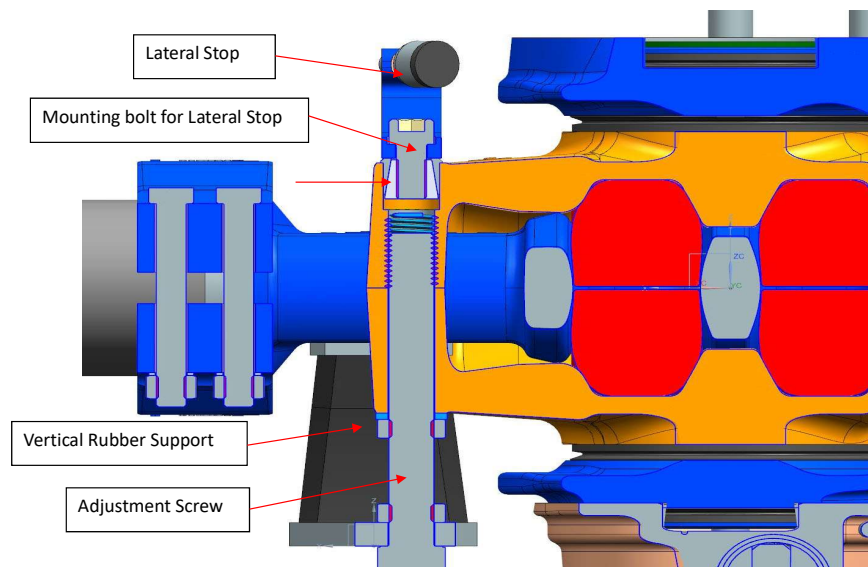
Further investigation into the engineering of the stop bracket mounting determined that the mounting bolt for the lateral stop bracket and the adjusting bolts for the coupler inclination occupied the same hole. If the coupler adjustment bolt was over tightened, compressing the rubber vertical support, the bolt would push the mounting bolt for the stop bracket out. With only 2mm clearance available between the puck and the coupler mounting plate, this was determined to be the root cause for the failure of the coupler.

*Exhibit 15 – Cross Section through Coupler Bearing Housing*

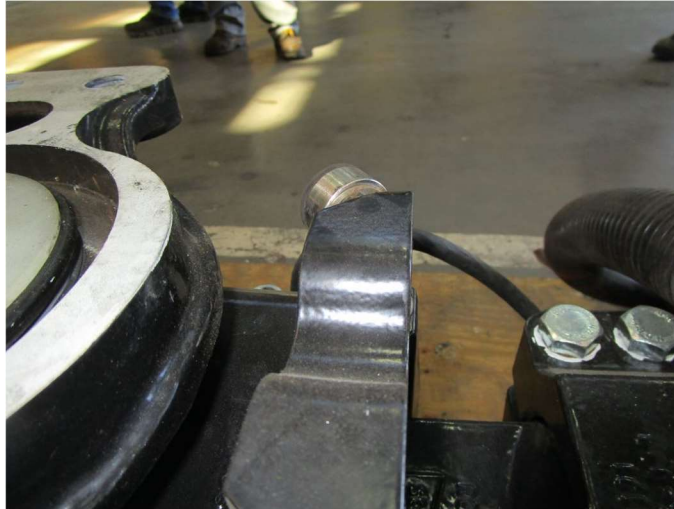
*Exhibit 17 – Lateral Stop Bracket Puck Extends 5MM above Bracket*

Second, the 2mm clearance between the lateral stop bracket puck and the coupler mounting plate was deemed insufficient. Therefore, because the stop bracket is only a bump stop to keep the coupler from damaging car underframe parts when a maintenance worker swings the coupler out of the way for servicing the car, a smaller diameter replacement puck that would not extend beyond the height of the lateral stop bracket would be adequate [*Exhibit 17*]. This would increase the clearance between the puck and the mounting plate to 7mm.

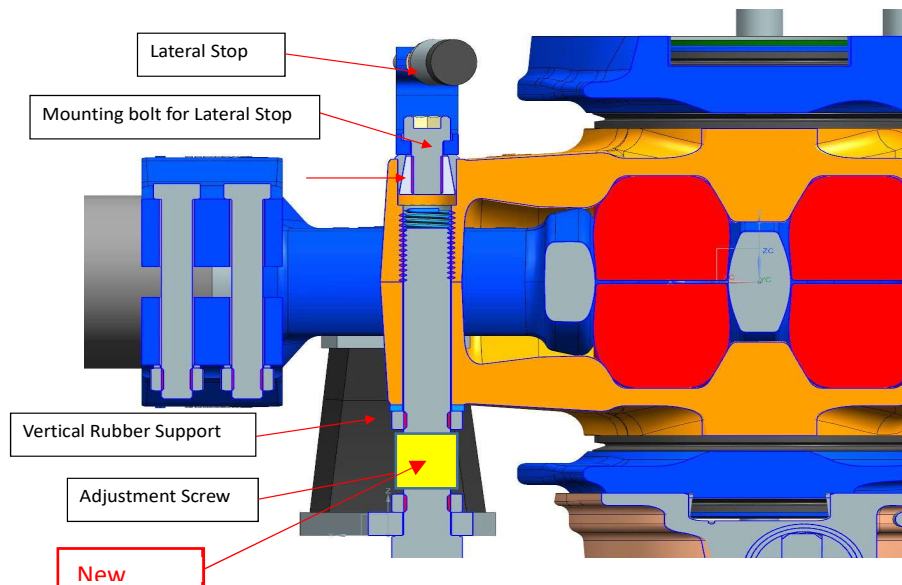
*Exhibit 18 – Cross Section through Coupler Bearing Housing with Proposed Sleeve*

Third, in order to prevent the adjustment screw from being over tightened due to, for example, not coupler height but wear of the rubber support, a sleeve spacer was installed on the Adjustment Screw to prevent the Adjustment Screw from being tightened such that it engages and pushes the mounting bolt for the lateral stop out of the clamshell [Exhibit 18].
