GOLDEN GATE PARK

EDGES IMPROVEMENT STRATEGY

OVERVIEW

This Existing Conditions Analysis is the first step in a longterm aspiration to improve the edges of Golden Gate Park. Its goal is to create a database and baseline for future decision-making and strategies to improve the edges of the park.

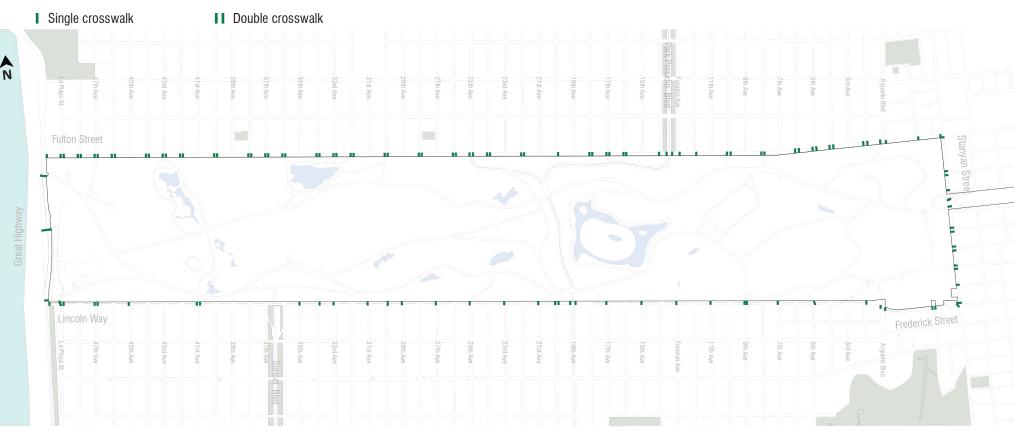
CROSSWALKS

Single crosswalk

Double crosswalk

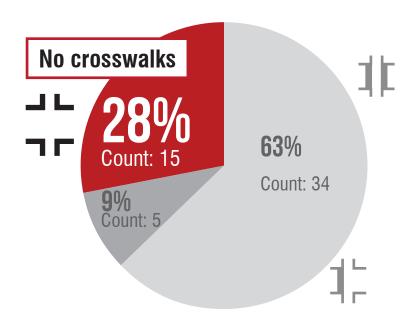
FULTON Street

28% of the intersections don't have crosswalks.

of intersections on Fulton St.: 54

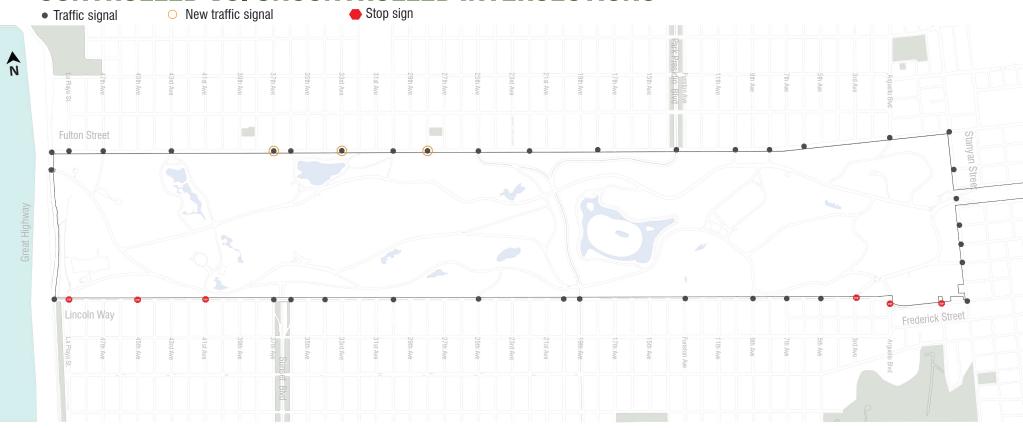
CONTROLLED VS. UNCONTROLLED INTERSECTIONS

Controlled

About two-third of intersections on Lincoln Way and Fulton Street are uncontrolled (no traffic signals or stop signs).

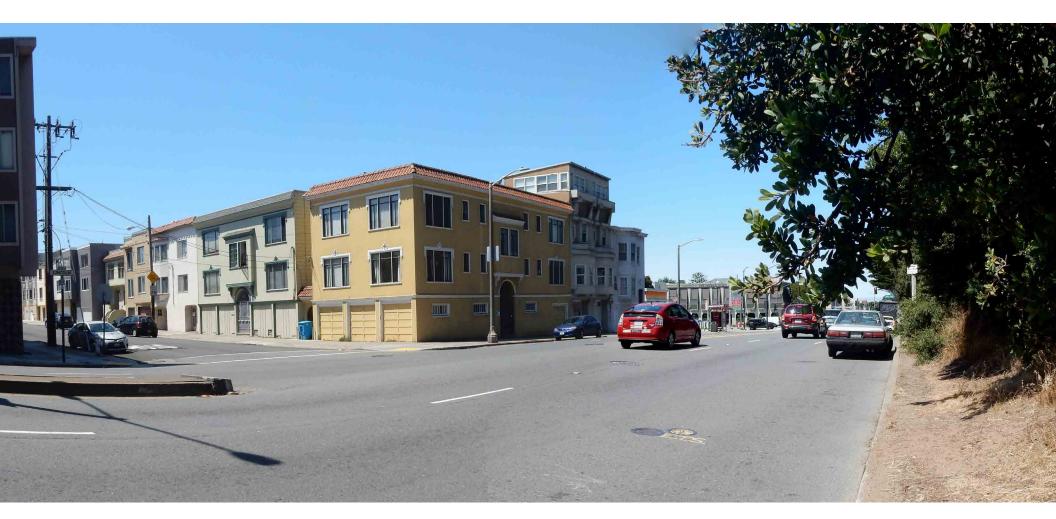
INTERSECTION ON LINCOLN WAY WITH NO CROSSWALK, TRAFFIC SIGNAL, STOP SIGN, OR SIDEWALK

Lincoln Way

CONCLUSION #1:

Many intersections lack the basic safety provisions necessary for pedestrian safety, particularly on the south edge of Golden Gate Park (Lincoln Way)

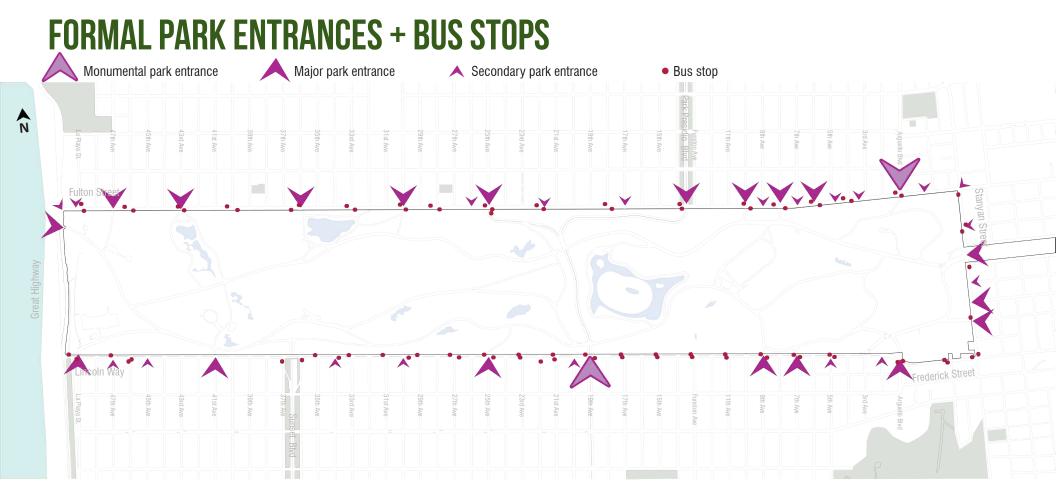
FORMAL PARK ENTRANCES

Monumental

Major

Secondary

The majority of formal park entrances have an adjacent bus stop, either directly at the entrance or no further than one block away.

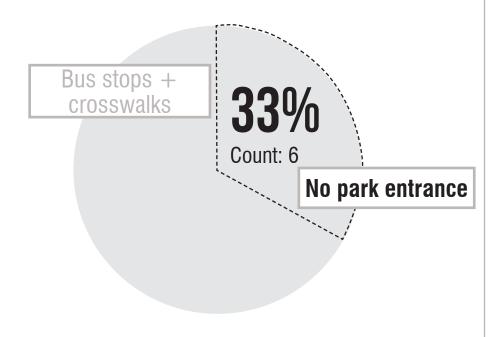
FULTON Street

About one third of the intersections with bus stops have no formal park entrances.

of intersections with bus stops.: 18

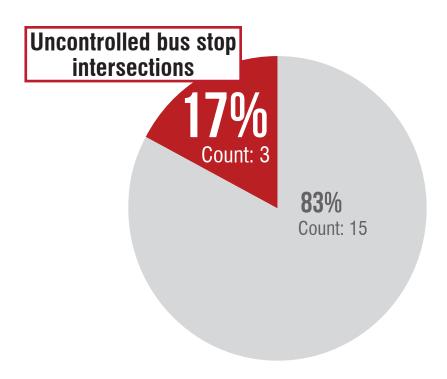
FULTON Street

About one fifth of the intersections with bus stops are not controlled.

of intersections with bus stops: 18

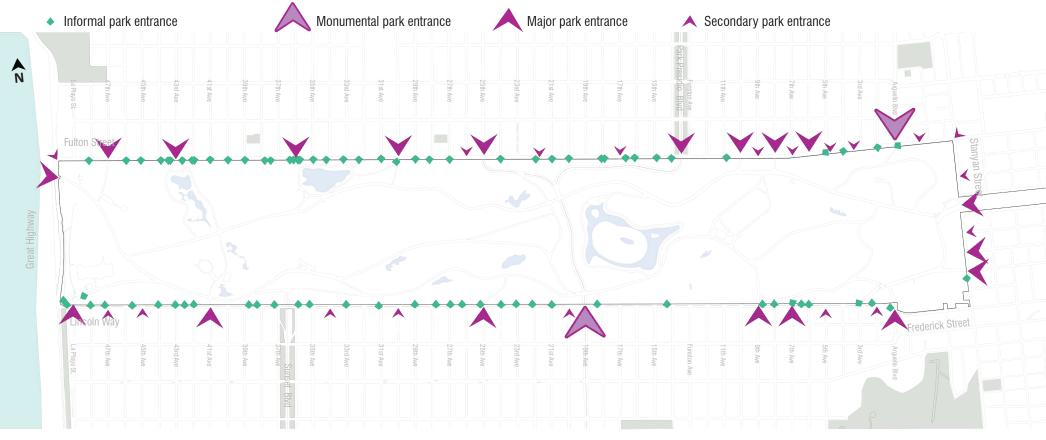
ENTERING THE PARK AT LOCATIONS WITHOUT FORMAL ENTRANCES

Number of informal park entrances mapped:

Fulton Street: 42

Lincoln Way: 36

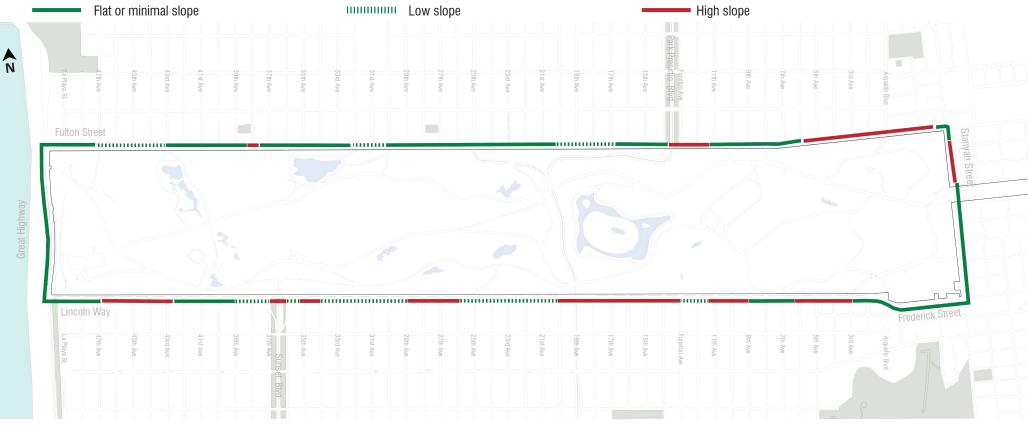
EDGES OF THE PARK ARE GENERALLY FLAT OR LOW-SLOPE

Note: based on a basic analysis of GIS terrain data. Needs to be studied and analyzed further.

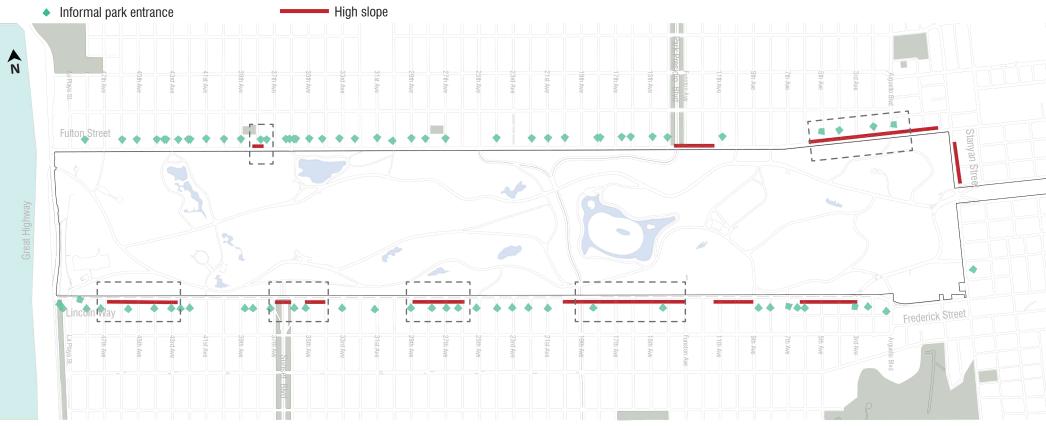
PEDESTRIANS STILL ATTEMPT TO ENTER THE PARK WHERE SLOPE IS HIGH

Note: based on a basic analysis of GIS terrain data. Needs to be studied and analyzed further.

CONCLUSION #3:

People are crossing the street and entering the park wherever they desire, regardless of the lack of a formal park entrance, safety measures (sidewalks, crosswalks, traffic signals/stop signs) or highly sloped terrain.

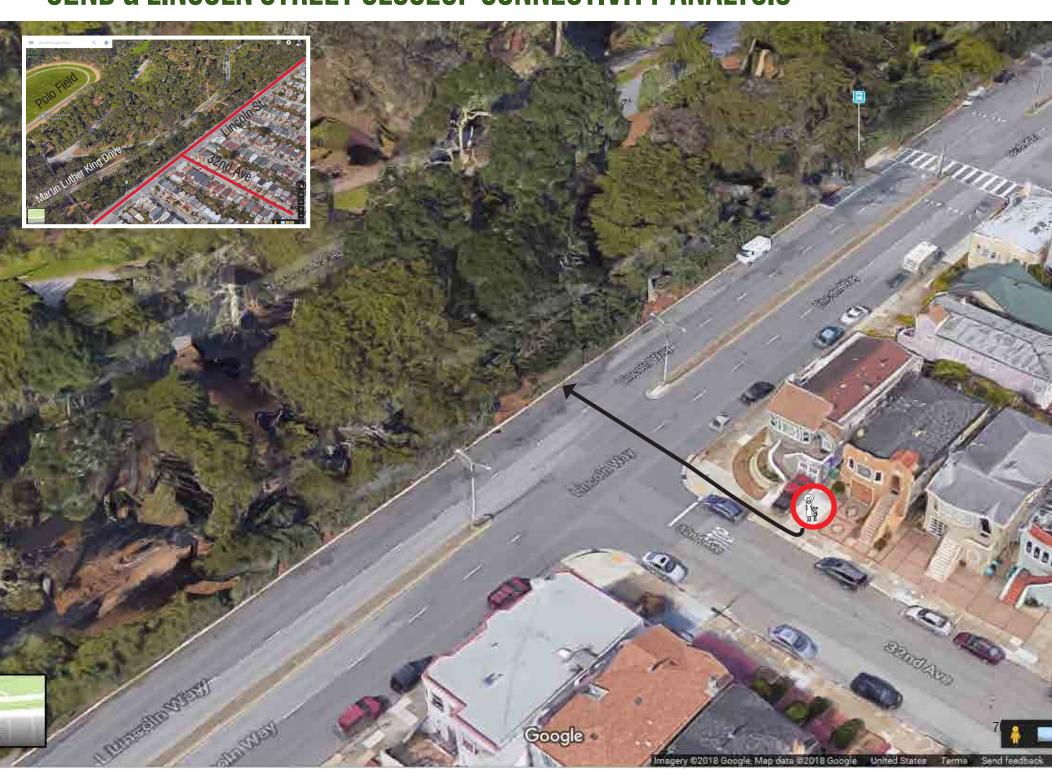
32ND & LINCOLN STREET CLOSEUP CONNECTIVITY ANALYSIS

32nd Ave and Lincoln Way

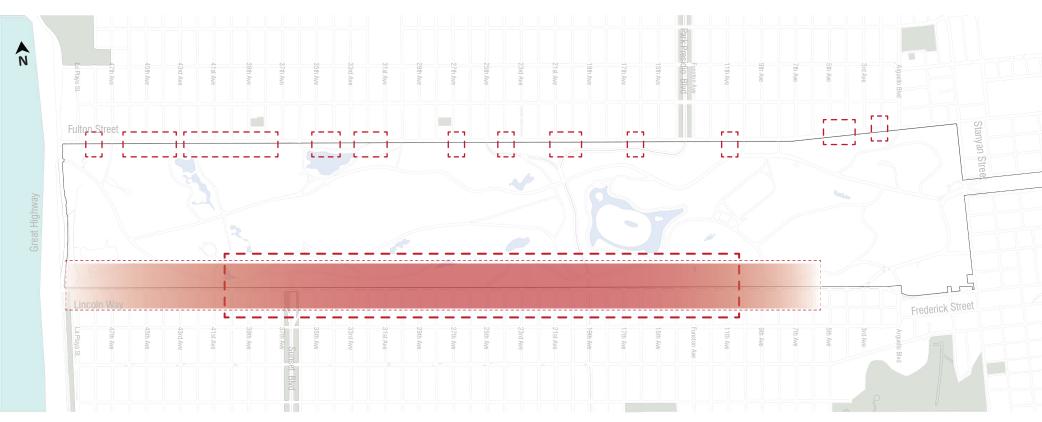
RECOMMENDED PRIORITY AREAS

Improve the level and quality of safety provisions on Lincoln Way, most urgently between 11th Ave and 40th Ave.

Improve level and quality of safety provisions at:

- Intersections lacking the necessary provisions, particularly on Lincoln Way.
- Bus stops on Lincoln Way.
- Informal park entrances on both Fulton St. and Lincoln Way.
