# LRV4 Project Update

SFCTA CAC Meeting  
February 26, 2020

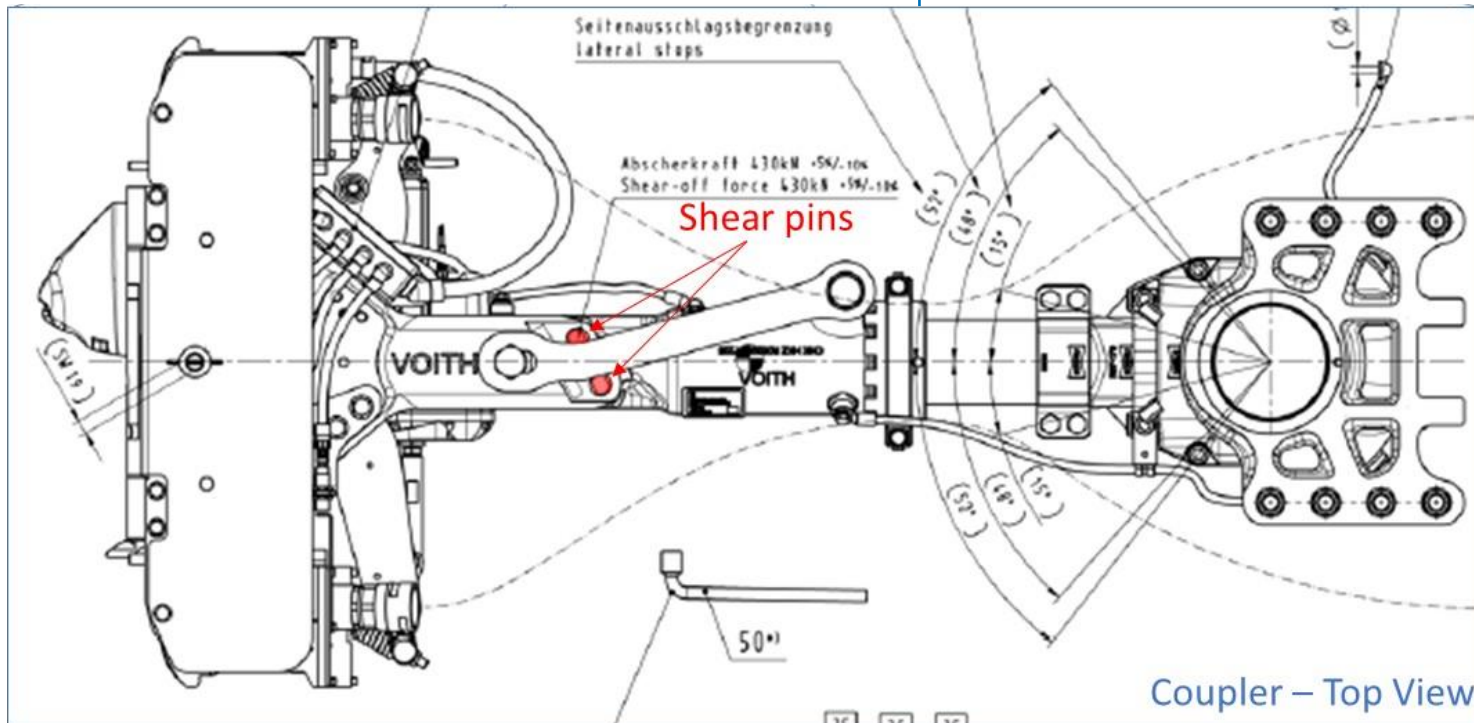
# Shear pin diagram

- Dec 11: Shear pins failed in service, two-car operations was restricted
- Dec 23: All shear pins replaced, two-car operations resumes without restrictions (pins will continue to be replaced every 90 days)
- Jan 2020: Data gathering completed, primary cause is sudden change of gradient at intersections
- Feb 2020: Full evaluation of data and redesign to address issue underway
- All costs covered by Siemens under warranty

- Request Prop K sales tax funding from SFCTA Board
- Initiate Contract Mod 7 for Phase 2 Breda replacement
- Re-design coupler to address shear pin issue
- Complete track brake installation end of March
- Accept remaining 3 cars and replace minimum diameter wheels on 6 cars
- Work with Operators to upgrade monitors

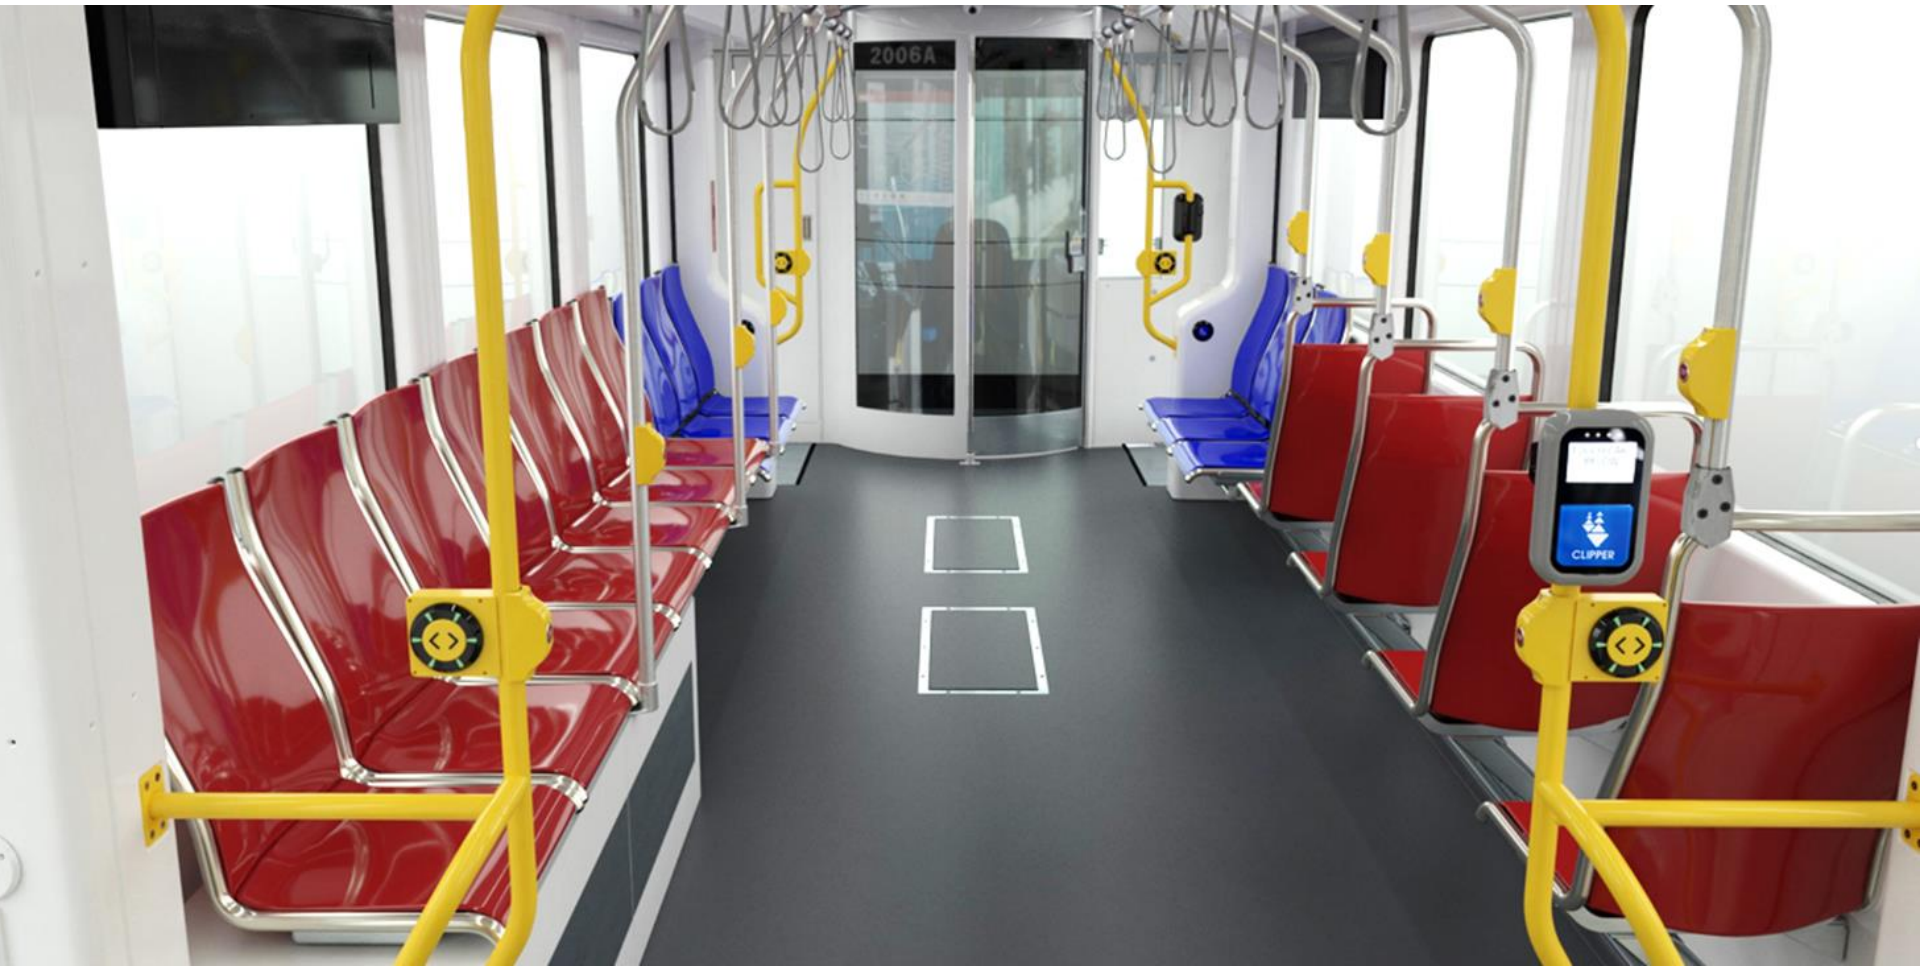
# Seating Arrangement – Single

*More blue seats will be added based on customer feedback*

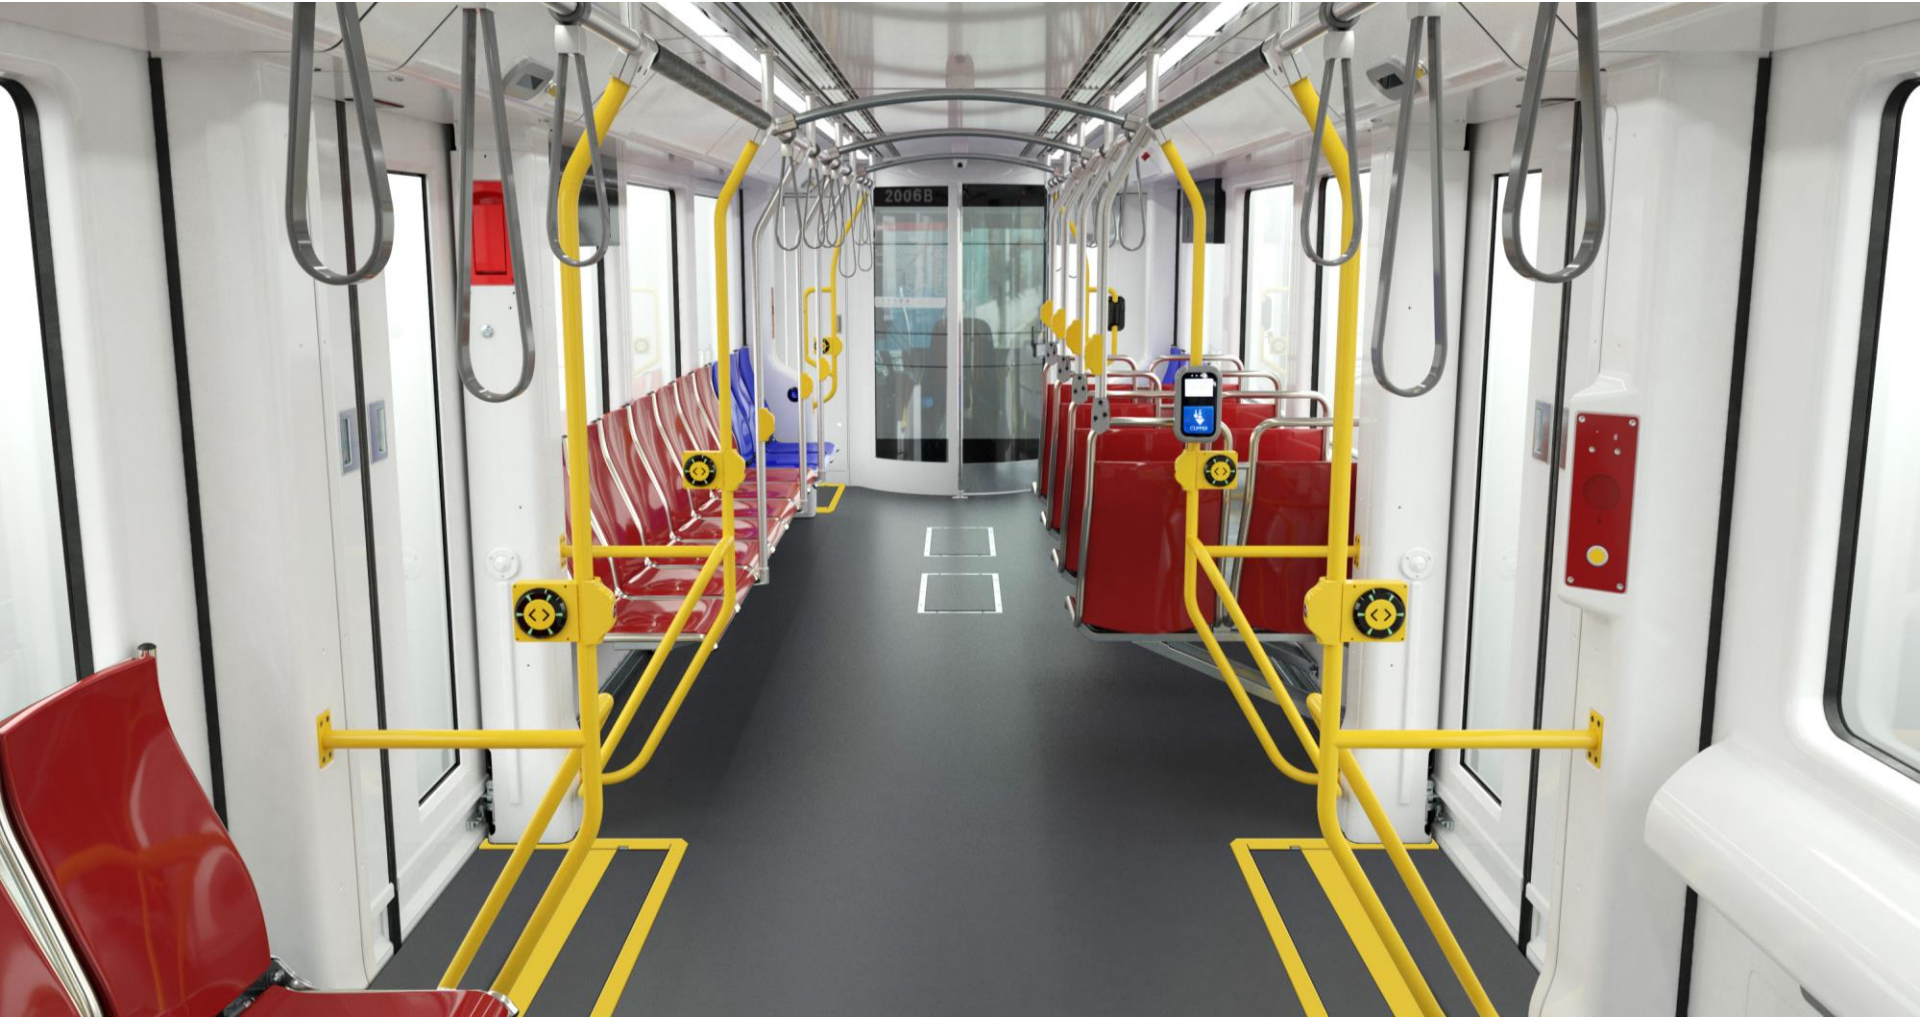
# Seating Arrangement - Double

*More blue seats will be added based on customer feedback*

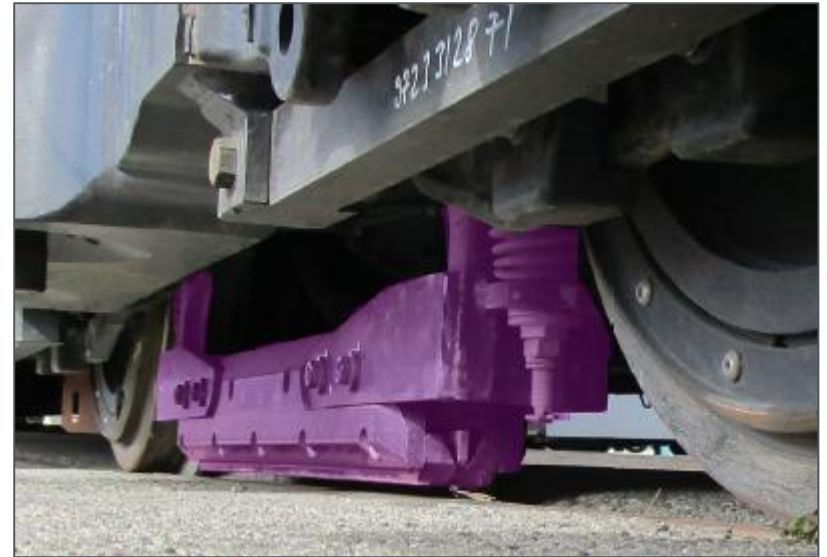
*Track brake highlighted in purple. Additional track brakes are being installed on the front and back of the train to reduce flat wheels and improve vehicle availability*
