Van Ness Corner Bulb Design Evaluation Report

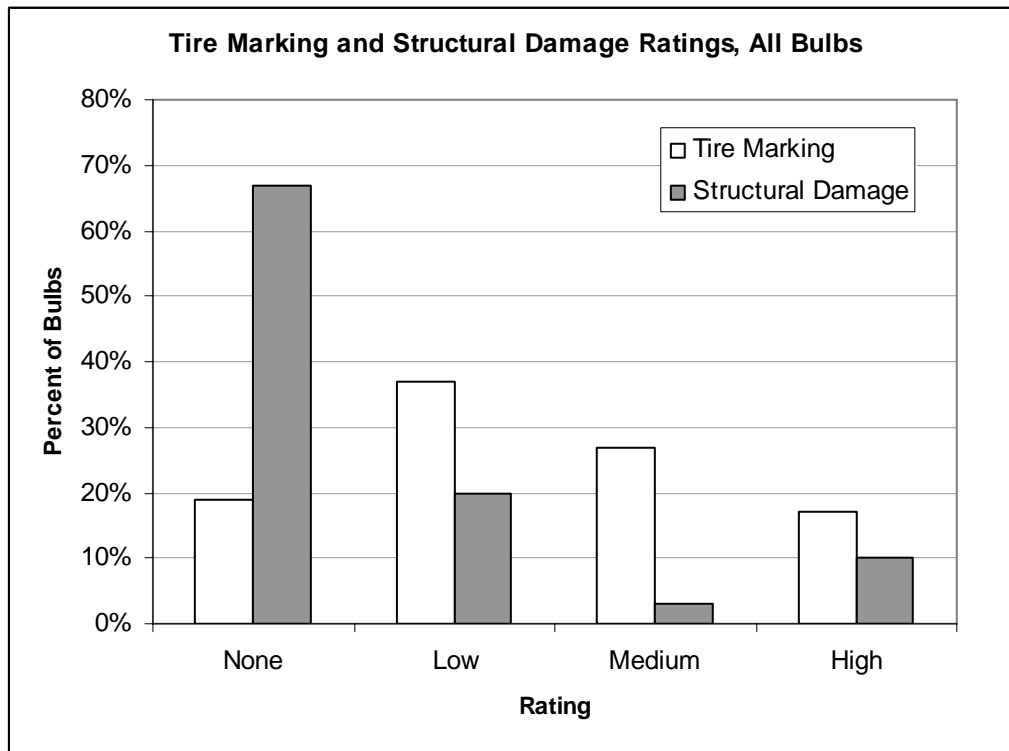
Figure 3. Summary of Tire Marking and Structural Damage Ratings

Thirty-three (33) percent of bulbs have some level of structural damage. Most of the damage is of low severity; only 13% of all bulbs had medium or high levels of structural damage. Table 2 synthesizes the level of damage to the Van Ness bulbs. See Appendix for individual bulb ratings.

Damage to the corner bulbs indicates interaction with vehicle traffic either making a right turning movement or exiting a parallel parking space. The field observations, discussed in a subsequent section, investigated the likely causes of damage. All damage, both tire marking and structural, occurs on the outer 6-12 inches of the curb.

The above analysis shows frequent tire markings and some damage to the outer areas of existing bulbs, suggesting that the current bulbs on Van Ness Avenue may be too wide and that a bulb one foot shorter may be more appropriate. This idea is explored further in Section C below.

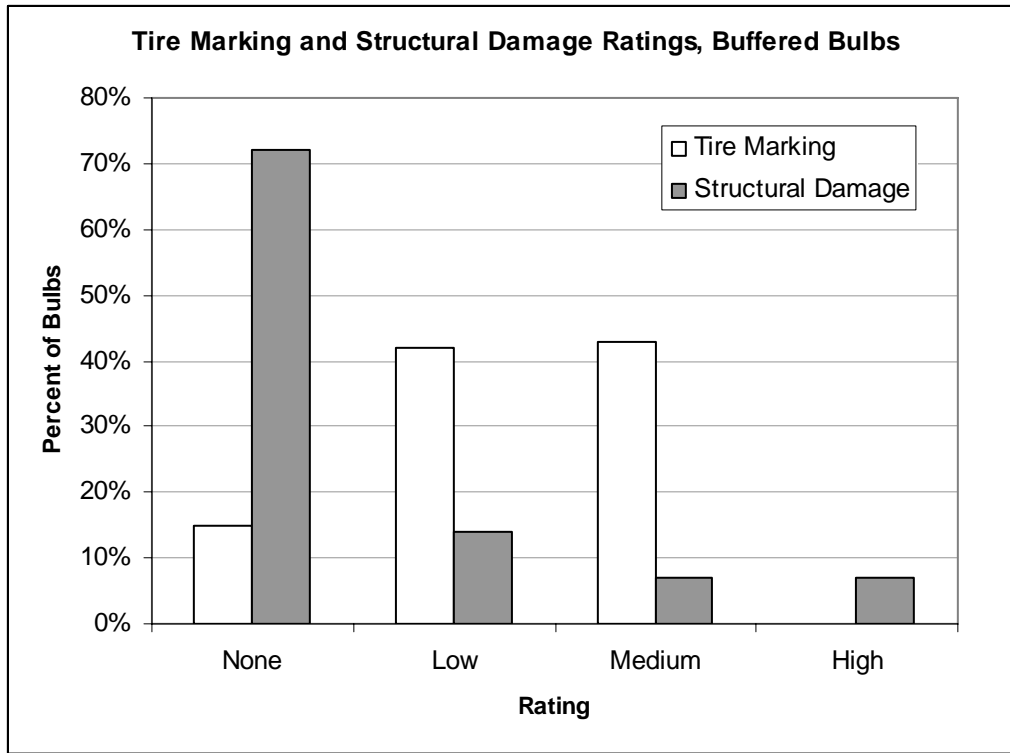
Figure 4. Summary of Tire Marking and Structural Damage Ratings, Buffered Bulbs

The team disaggregated the analysis of corner bulbs with a striped buffer from the analysis of all bulbs to determine whether the buffer helps to reduce damage on those outer 6-12 inches. It is difficult to make a conclusive finding here because there exists no baseline data regarding bulb condition before the buffers were installed. The analysis can only compare cumulative data between buffered and non-buffered bulbs.

The percentage of buffered bulbs showing no damage is not significantly different from that for all bulbs. There is, however, some difference relating to severity of marking and damage; 'high' ratings are down slightly for buffered bulbs, indicating a potential beneficial effect.
