Memorandum

SUBJECT: 2/25/20 Board Meeting: Independent Management and Oversight Report on the San Francisco Municipal Transportation Agency's Siemens Light Rail Vehicle Procurement

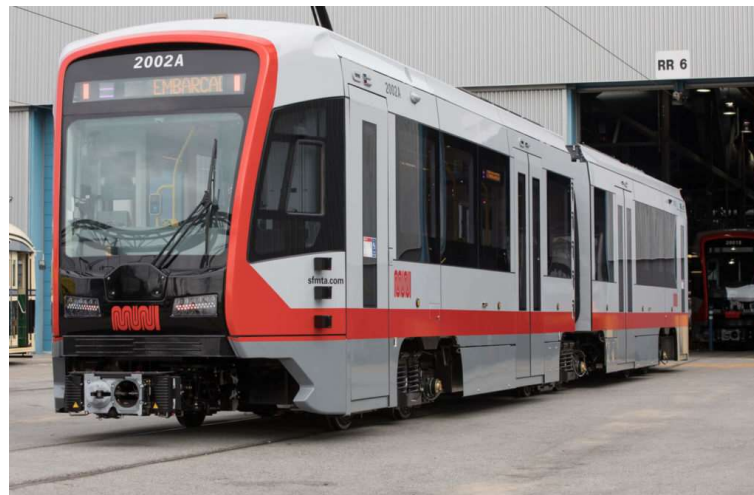
Exhibit 21 – LRV4 Single Car at MME

The LRV4 cars are equipped with both hydraulic friction brake systems on the wheels and with electro-magnetic track brakes on the center bogie. The track brakes engage the track to stop the car.

The combination of the wheel brakes and track brakes stops an LRV4 within the required distances and speeds without damage to the LRV or track structure. This requires that additional pressure be applied by the wheel’s brakes and therein we get wheel lock. It was determined that if less pressure were applied to the wheel’s brakes, such that they would not lock up, and more pressure were applied by track brakes, such that the car would still stop within the required distances, additional track brakes would need to be installed on the end bogies. This would not damage either the LRV or track structure.
