# Memorandum

**DATE:** February 21, 2020  
**TO:** Transportation Authority Board  
**FROM:** Eric Cordoba- Deputy Director for Capital Projects  
**SUBJECT:** 2/25/20 Board Meeting: Independent Management and Oversight Report on the San Francisco Municipal Transportation Agency’s Siemens Light Rail Vehicle Procurement

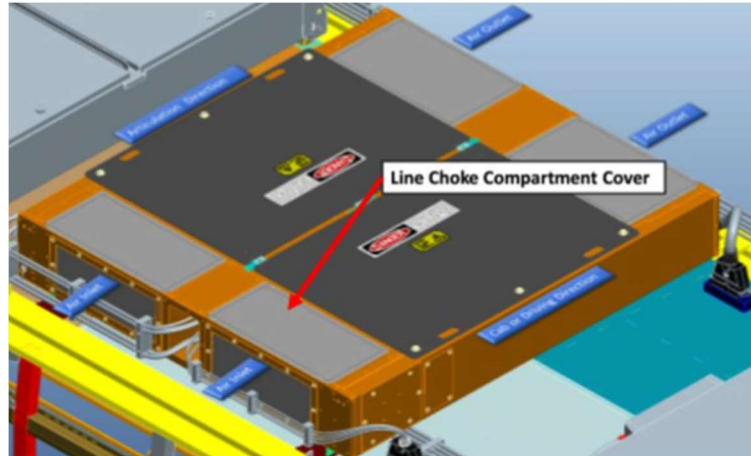
*Exhibit 1 - Schematic of Car Roof*

During the rainy season, there were a number of failures attributed to water being captured in the compartment and not draining. Water is permitted by design to enter this compartment, however without adequate drainage localized arcing occurred in the APS unit.

The root cause was determined to be the mounting of the APS unit. The APS unit brackets placed the bottom of the APS unit at approximately the same plane as the bottom of the compartment [*Exhibit 2*]. Therefore, water would accumulate in the compartment and not be able to get under/past the APS unit to the drain, splash into the APS and arcing would occur. The water volume, although minimal, was enough that during car movements the water would splash into the APS unit and the APS unit would fail. Note that the APS unit requires air circulation for cooling and is therefore not sealed from water.

Once the root cause had been identified, washers were placed between the APS mounting frame ears and the compartment floors as a temporary fix to provide clearance for drainage on 100% of the cars. The permanent solution, which has been installed on all phase 1 LRV4s, is the new raised mounting brackets.

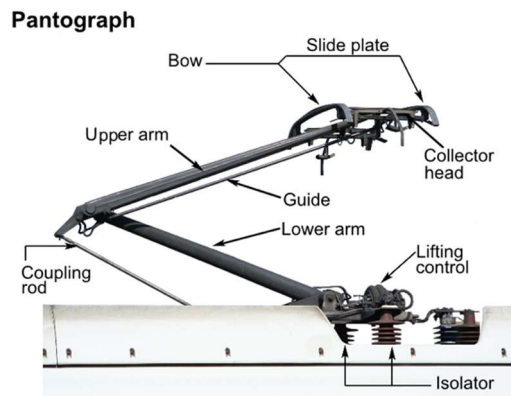
*Exhibit 6 – ICE Train Pantograph [note LRV4 cars use two double slide plates]*

The failure occurred when energy moved through the slide plate mounting bolts that were installed using Nylock nuts. The nylon on the nuts failed because they overheated from the current, which resulted in a slide plate partially separating from the pantograph frame. Because the car was in a tunnel and the pantograph collector head was only two feet above the car roof, the slide plate touched the roof of the car causing a fault.

There were two root causes for this fault. First, hardware such as the Nylock nuts should not have been used in this application because the pantograph is fully charged. Second, in this application, the current should not be going through hardware but through shunts. Shunts are devices such as cables that provide a low resistance path for electric current.

Although there was only one such failure in the system, because of the severity of the failure and the potential to damage not only a car but also the catenary, all Nylock nuts on the pantographs were replaced with metal Nordlock washers and standard nuts. Also, eight (8) shunts were installed on each pair of collector heads to direct the path of the current from the graphite collectors and blocks through the shunts to the pantograph arms, thereby moving the current around the mounting hardware.

The solution has been tested and approved by the Safety and Security Subcommittee including CPUC. All pantographs have since been modified, as a Siemens warranty repair, and the issue is closed.

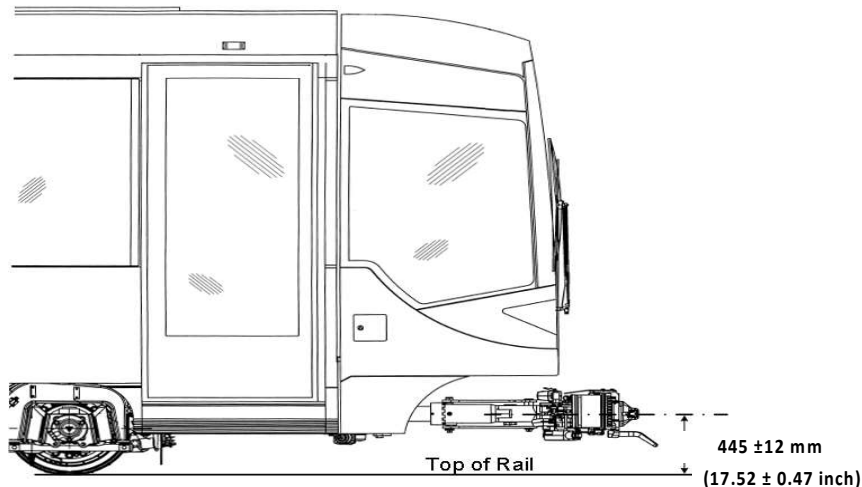
*Exhibit 13 – SII-MTA-1021A SMI-OSAT-SFMTA Mechanical Adjustment Rev 1\_3, Pg. 9*

There are adjustment bolts for the coupler inclination. The coupler must be level to the track to perform properly. Exhibit 13 shows the maintenance instruction for adjusting the couplers.

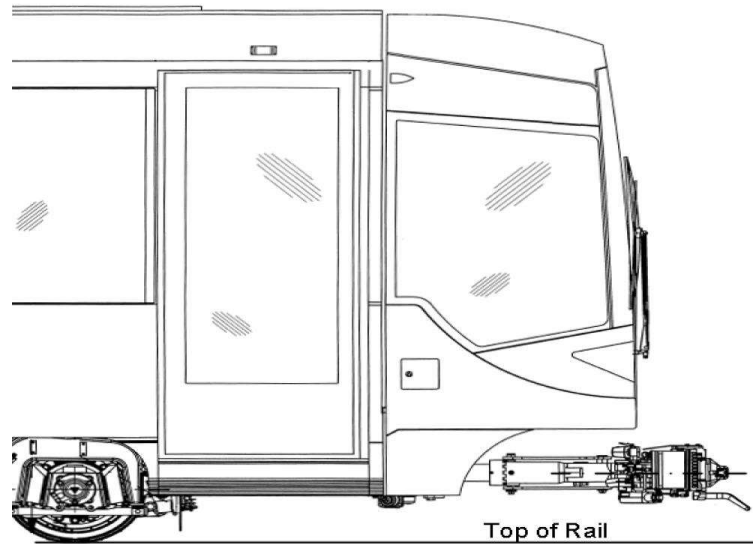
*Exhibit 16 - SII-MTA-1090A SMI-OSAT-SFMTA Mechanical Adjustment Rev 1\_6, Pg 9*

Further investigation into the engineering of the stop bracket mounting determined that the mounting bolt for the lateral stop bracket and the adjusting bolts for the coupler inclination occupied the same hole. If the coupler adjustment bolt was over tightened, compressing the rubber vertical support, the bolt would push the mounting bolt for the stop bracket out. With only 2mm clearance available between the puck and the coupler mounting plate, this was determined to be the root cause for the failure of the coupler.

Second, the 2mm clearance between the lateral stop bracket puck and the coupler mounting plate was deemed insufficient. Therefore, because the stop bracket is only a bump stop to keep the coupler from damaging car underframe parts when a maintenance worker swings the coupler out of the way for servicing the car, a smaller diameter replacement puck that would not extend beyond the height of the lateral stop bracket would be adequate [*Exhibit 17*]. This would increase the clearance between the puck and the mounting plate to 7mm.

Third, in order to prevent the adjustment screw from being over tightened due to, for example, not coupler height but wear of the rubber support, a sleeve spacer was installed on the Adjustment Screw to prevent the Adjustment Screw from being tightened such that it engages and pushes the mounting bolt for the lateral stop out of the clamshell [Exhibit 18].

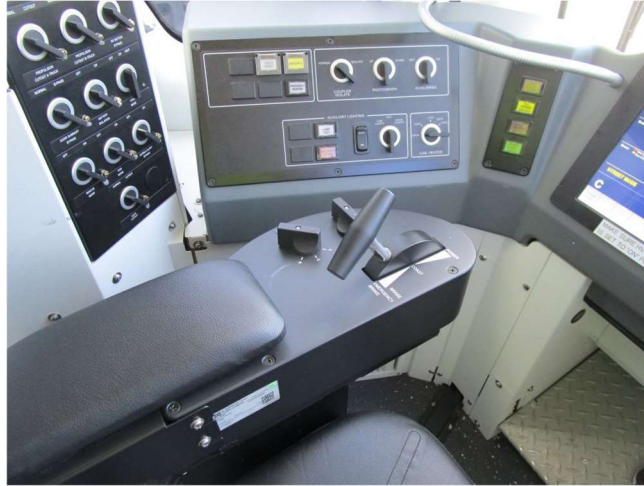
*Exhibit 19 – LRV4 ‘T’ Handle in 90 Degree Off Position*

The old Breda cars and the new Siemens LRV4 cars have similarly positioned braking controls although the effects of the controls are slightly different. The 'T' handle controller on both cars accelerates and stops the cars [Exhibit 19]. For an emergency stop the Breda 'T' handle is pulled straight back and twisted 90 degrees. The Siemens 'T' handle is just pulled straight back but not twisted.

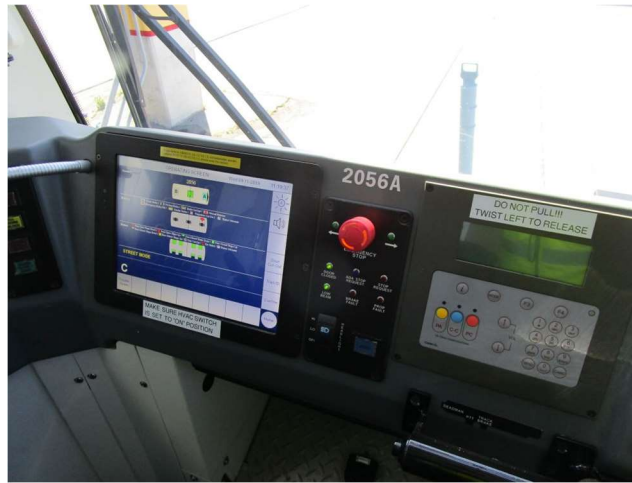
*Exhibit 20 – LRV4 Emergency Red Stop Button*

The emergency stop button (referred to as the “mushroom”) on both cars is in the same position and when hit, puts the car into emergency stop mode [Exhibit 20]

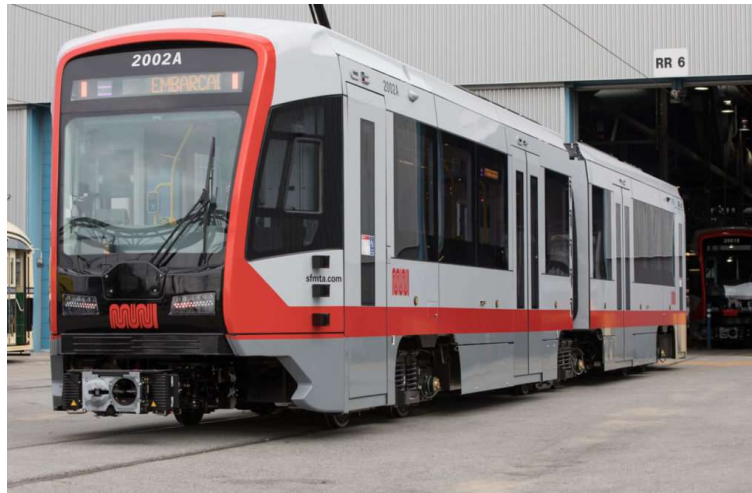
*Exhibit 21 – LRV4 Single Car at MME*

The LRV4 cars are equipped with both hydraulic friction brake systems on the wheels and with electro-magnetic track brakes on the center bogie. The track brakes engage the track to stop the car.

The combination of the wheel brakes and track brakes stops an LRV4 within the required distances and speeds without damage to the LRV or track structure. This requires that additional pressure be applied by the wheel’s brakes and therein we get wheel lock. It was determined that if less pressure were applied to the wheel’s brakes, such that they would not lock up, and more pressure were applied by track brakes, such that the car would still stop within the required distances, additional track brakes would need to be installed on the end bogies. This would not damage either the LRV or track structure.

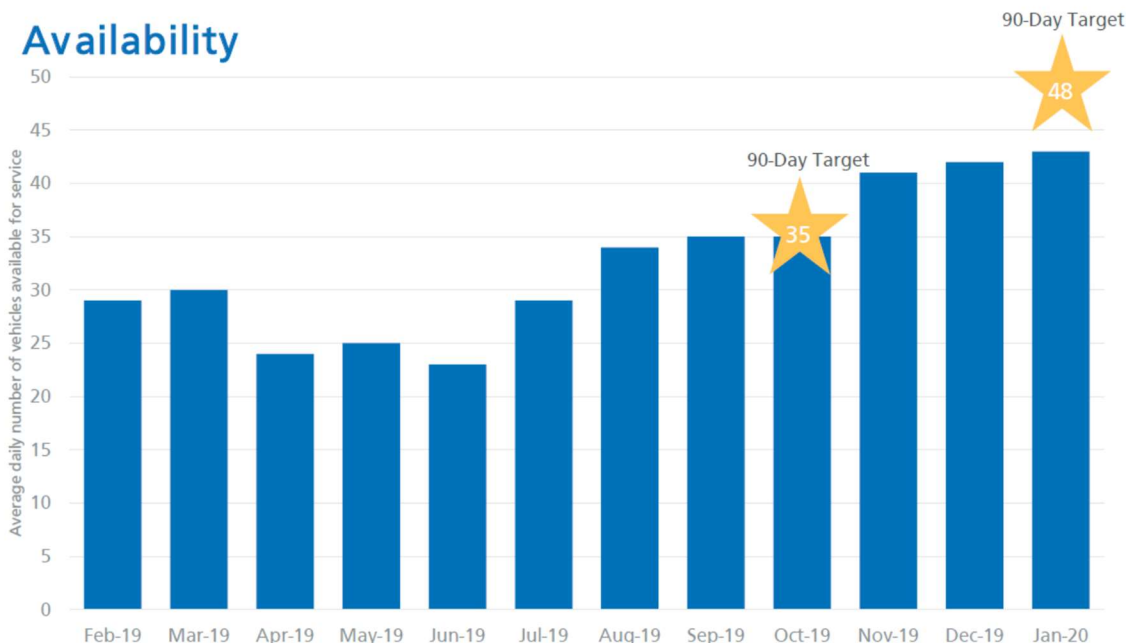
*Exhibit 23 – LRV4 Daily Availability*

The MDBF improvement also contributes to the increased availability of LRV4s for revenue service. Exhibit 23 shows the daily availability of LRV4s over time. This accounts for delivery of vehicles and availability due to planned and unplanned maintenance activities.
